# PROFESSIONAL RESERVE STUDY

## Heritage Park

3208 - 52<sup>nd</sup> Place NE, Tacoma, WA 98422

**June 23, 2022**

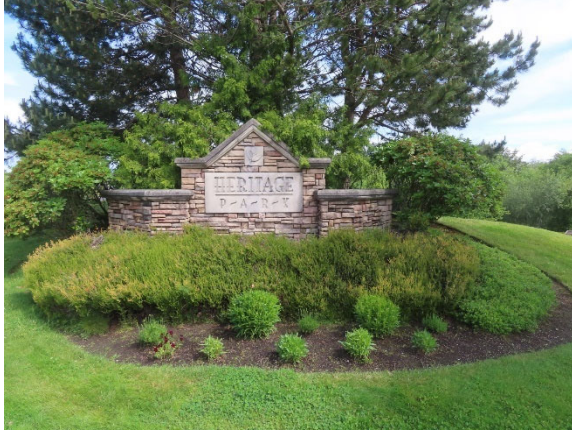
West Entrance Monument

There are entrance monuments at the two entrances to Heritage Park. The monuments will require a small amount of maintenance in the form of cleaning, painting, sealing, and tuck-pointing of the masonry. This level of maintenance has been scheduled every 10 years.

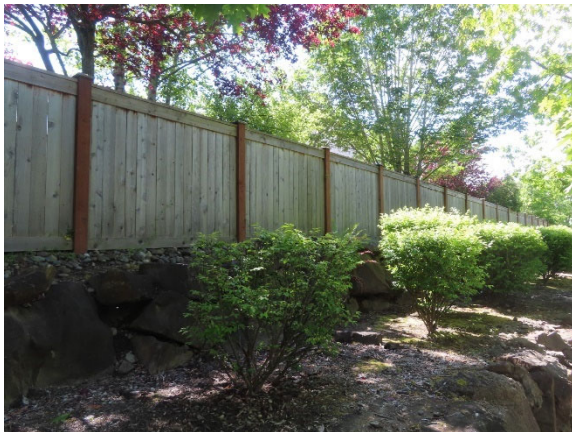
Common Fencing

The homeowners association is responsible for the maintenance and eventual replacement of the common wood fencing on both sides of the south boulevard near at the south entrance to this property. We understand that this wood fencing was replaced in 2018. This fence should have a total lifespan of 25 years if it is maintained by staining and spot replacement every 5 years.

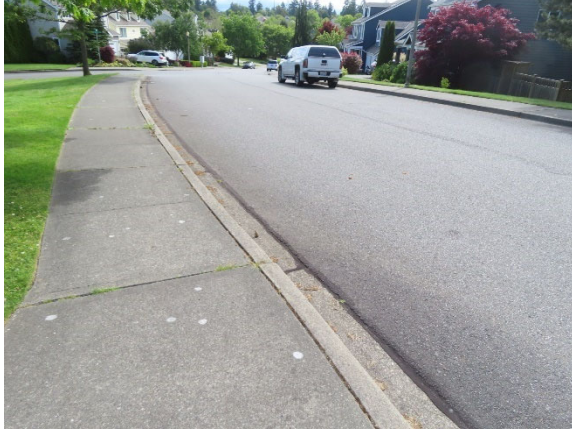
All of the streets in this development are public and are not maintained via the homeowners association. However, the HOA is responsible for the maintenance and eventual replacement of the asphalt walking paths in the community park. The walking paths had significant repairs in 2020. As this walking path will not receive any vehicle traffic, we have assumed that the asphalt walking paths will have a 30-year service life before an asphalt overlay is necessary.

Typical Public Street

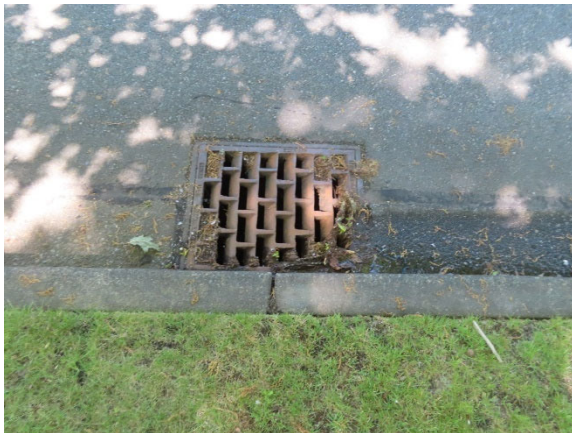
Typical Storm Drain

The storm system on this property is public and is not maintained via the homeowners association.

There is a drainage issue near the west entrance that will need to be corrected in 2022. We have budgeted for this project as a one-time expense.

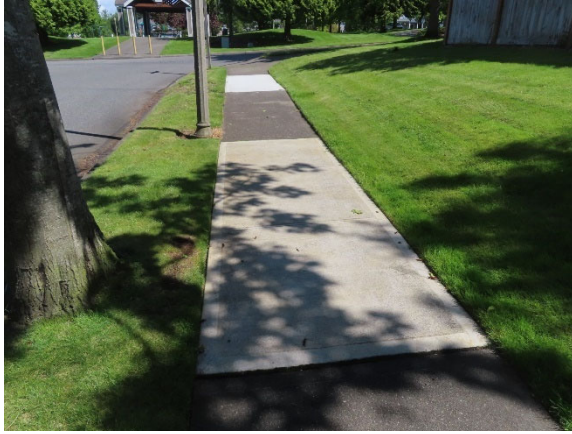
Concrete Sidewalk

The concrete sidewalks and square concrete curbing that are adjacent the roads within the development are maintained by the homeowners association. Additionally, the sidewalks located along Northshore Parkway NE and Norpoint Way NE are also maintained by the homeowners association. There are currently concrete sidewalk repairs that are necessary. We have assumed that a similar level of concrete sidewalk maintenance will be necessary every 5 years.

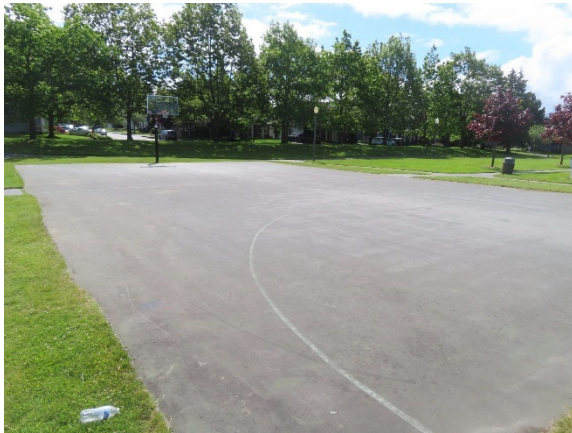
Basketball Court

There is a basketball court in the common park. We have budgeted for resurfacing of the basketball court in 2023 and every 20 years thereafter. We have also budgeted for the replacement of the backboard assemblies every 10 years. However, this duration could vary up or down depending on the quantity of use and care that is taken.

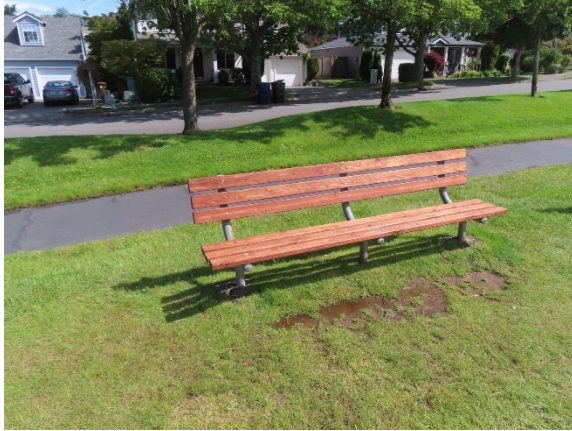
Typical Park Bench

There are picnic tables and benches in the common park. The wood in these benches was recently replaced in 2021 by Tom Tagart. Rather than budget for each bench to be replaced, we have simply budgeted for a small allotment for replacement of some of this equipment as necessary every 10 years.

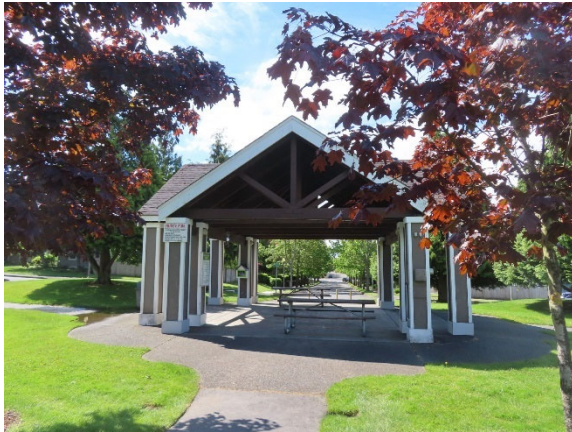
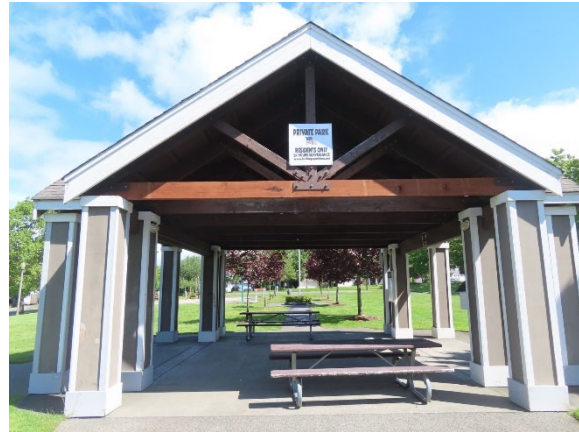
Pergola

There is a pergola in the common park. This pergola is relatively simple. We have assumed that the structure and cladding of this pergola will have a lifespan beyond the duration of this study if maintained by paint and stain. We understand that the homeowners themselves periodically paint the pergola and that no Reserve Funding will be used to paint this structure. We have included in the Reserve Study the cost to resurface the roof of this pergola every 30 years as the roof surfacing has a 30-year nominal service life.

We understand that there were recently some structural repairs to the pergola in 2021; however, we do not anticipate this to be a repeat expense going forward.

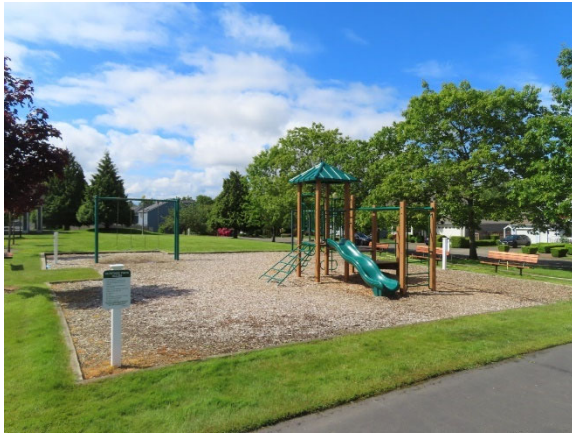
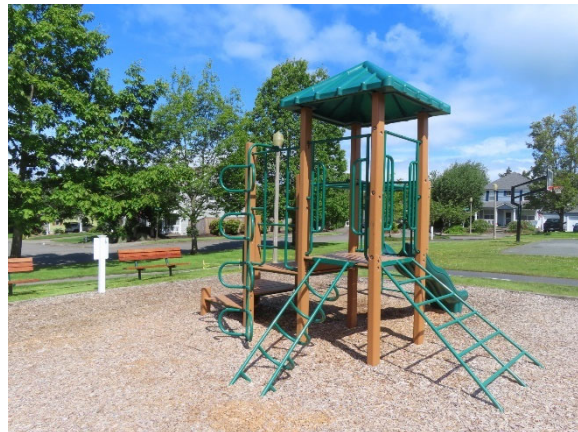
Playground

There is a playground structure in the common park that was installed in 2016. This playground equipment consists of metal and plastic. We have assumed that minor maintenance of the playground equipment can occur by the residence of this community and that staining can occur via the operating budget. Therefore, we have assumed a total lifespan of 20 years for the playground structure.

We have included the addition of playground chips every 3 years in the Reserve Study and we have done so.

There was drainage mitigation of this playground that was done in 2021. We do not anticipate this to be a repeat project.

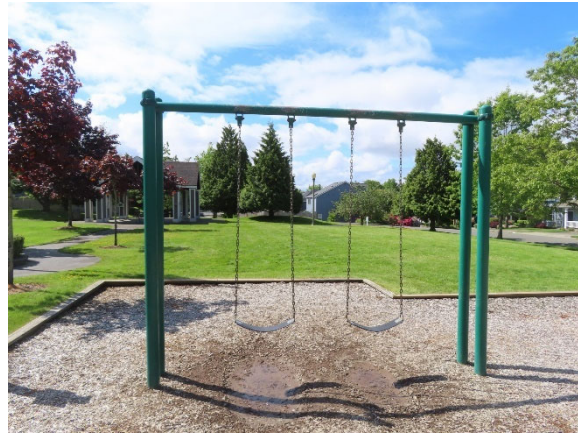
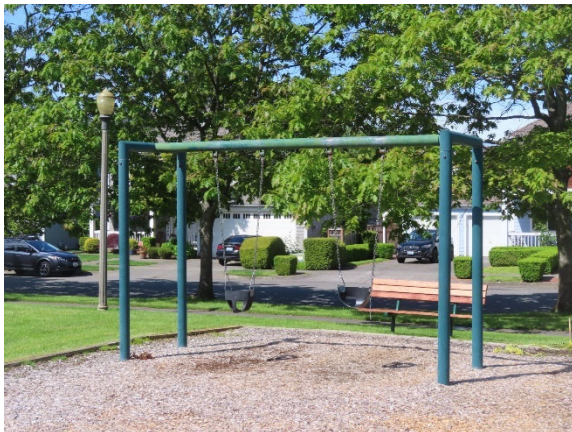
One of Two Swing Sets

The two swing sets should have a lifespan beyond the duration of this study. Periodically, smaller components of these swing sets will need to be replaced, which are small costs.

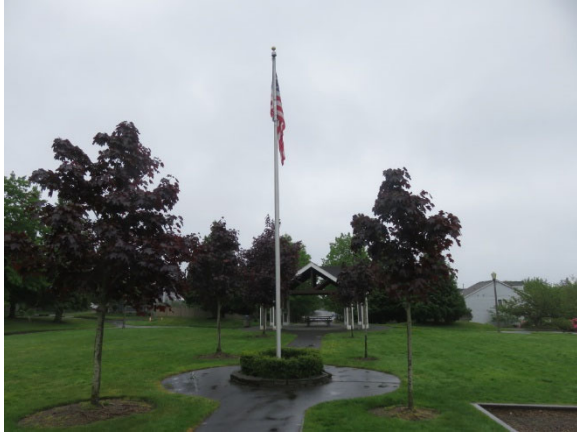
Flag Pole

The flag pole in the common park should have a lifespan beyond the duration of this study. The flag will need to be replaced; however, this is relatively inexpensive and is not factored into the Reserve Study.

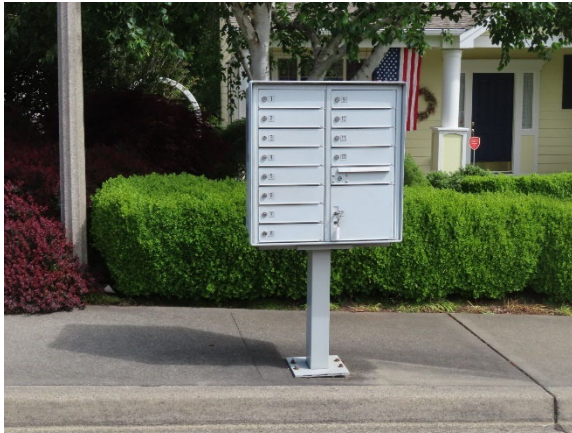
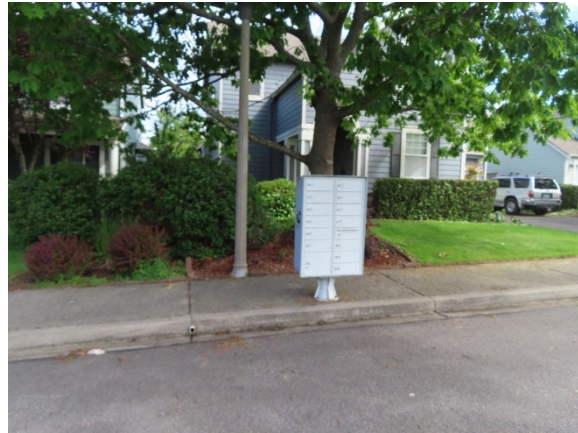
The mailbox kiosks are owned by the United States Post Office and are not the responsibility of the homeowners association.

Typical Mailbox Kiosk

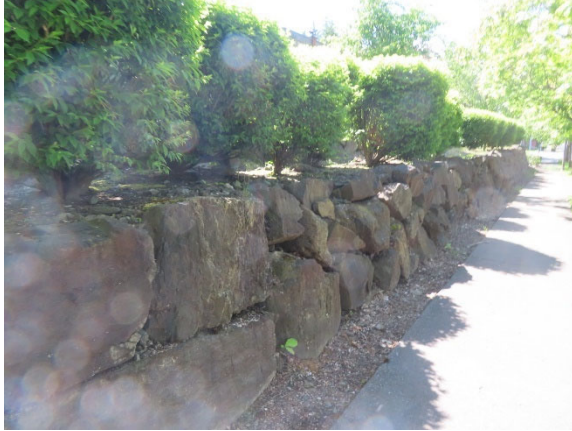
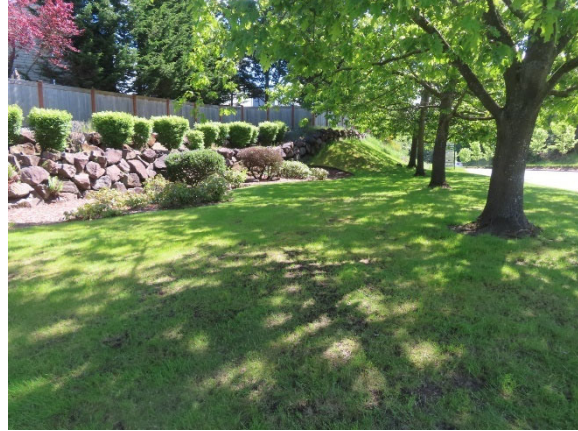
Rock Wall

There is a rock wall along the south entrance. This wall should be relatively easy to maintain via the operating budget and landscaping crew if there is rocks that fall out of place. Therefore, no funding has been designated for this rock wall from the Reserve Fund.

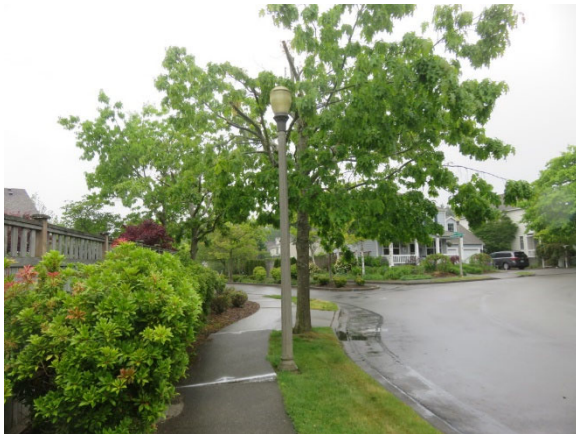
Typical Concrete Light

The majority of the concrete lights in this development are located along the streets and are the responsibility of the local municipality. The concrete lights in the park are the responsibility of the homeowners association; however, these lights should have a life span beyond the duration of this study, unless a vehicle hits these lights. In which case, that should be paid for via the offending driver's insurance. The replacement of the light ballasts should be paid for via the operating budget.
